1. Report No.	2. Government Accession No.	3. Recipients's Catalog No.	
4. Title and Subtitle  Inspection and Testing of Low Speed Vehicles		5. Report Date August 1998

6. Performing Organization Code NRD-23	
7. Author(s) Jeff Elias		8. Performing Organization Report No. VRTC-83-0461	
9. Performing Organization Name and Address National Highway Traffic Safety Administration Vehicle Research and Test Center P.O. Box 37 East Liberty, OH 43319		10. Work Unit No. (TRAI5)n code

14. Sponsoring Agency Code	
15. Supplementary Notes			
<p>16. Abstract</p> <p>In response to petitions by the golf cart industry the National Highway Traffic Safety Administration reviewed its position on low speed vehicles and has taken steps to define a new class of low speed vehicle (LSV) which is exempt from the federal motor vehicle safety standards (FMVSS) that apply to motor vehicles. A new safety standard, FMVSS 100, has been proposed to regulate this new class of vehicle.</p> <p>The Vehicle Research and Test Center conducted a survey and a series of tests to evaluate the safety and stability of LSVs. Two neighborhood electric vehicles, the Bombardier and the GEM, and one golf car, the Yamaha gasoline pow

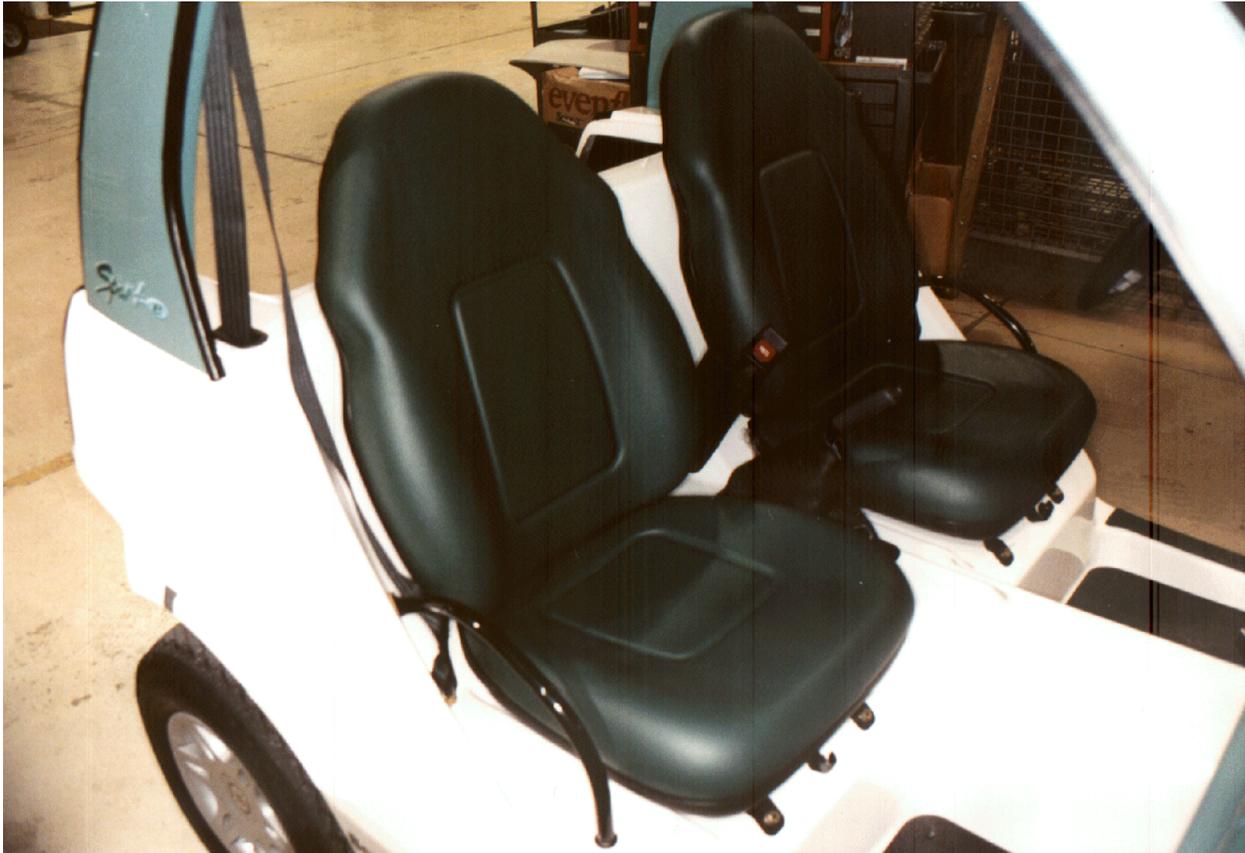
Figure 3 - (Bombardier) - Details of Bucket Seats. Note rails for lateral restraint (golf cart) as well as seat belts. Also note long stem on buckle (center) allowing for high placement of lap belt.

In addition to the lateral restraints, the vehicle was equipped with two 3-point retractable seat belts with inertial lock ups on the reel. The buckle was mounted on a fairly long stem. As a result, the lap portion of the belt system can inadvertently be positioned to ride high on the occupant's hips. In a passenger vehicle this condition often results in the belt riding over the iliac crest and creating a submarining condition in a frontal crash, with the potential for causing associated abdominal and spinal injuries.

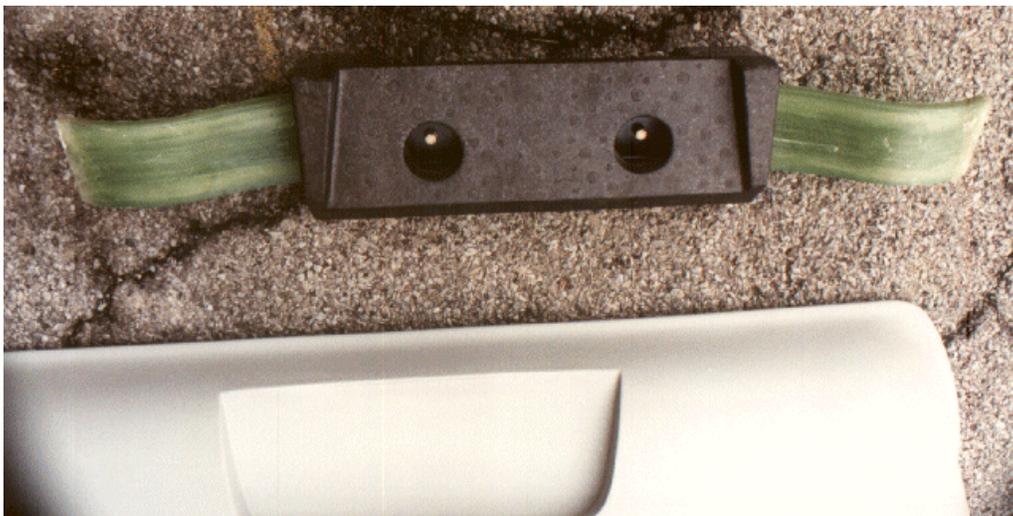
The bumpers of the vehicle had a very light and flexible cosmetic cover. Beneath the cover was a block of closed cell foam (similar to Styrofoam) backed with a long polymer/fiberglass flat spring structure (see Figures 12 and 13). The rear bumper attached directly to the differential. The rack and pinion gearing was located directly behind the front bumper attachment (See Figure 14).

Figure 12 - Rear Bumper and Bumper Cover

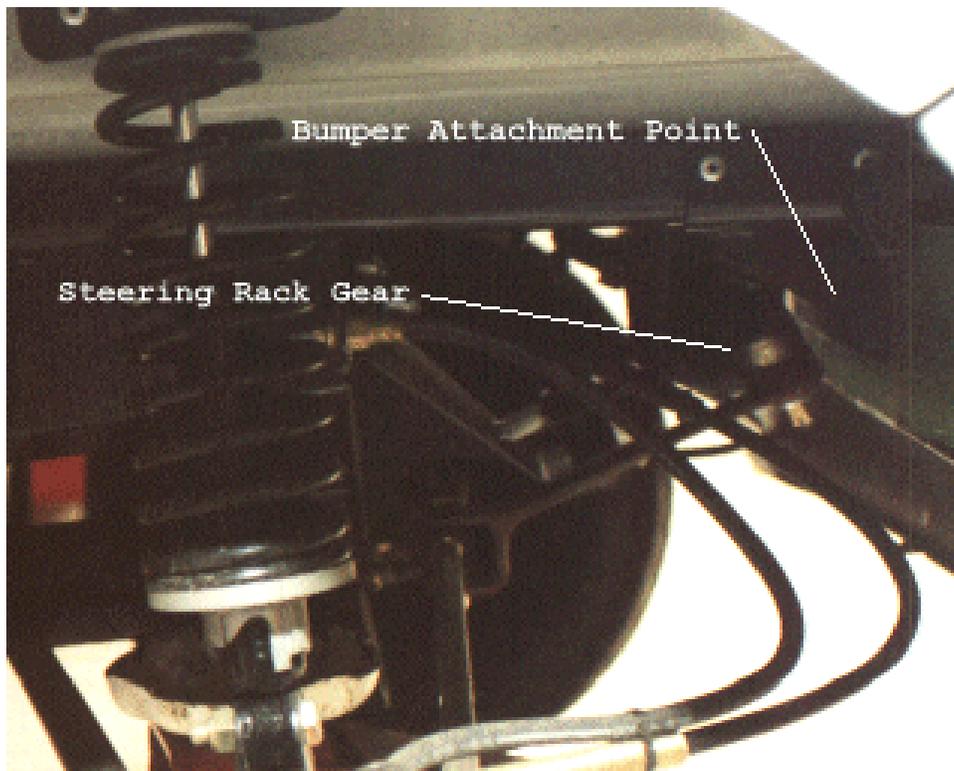
Figure 14 - Details of Steering Components and Bumper Attachments

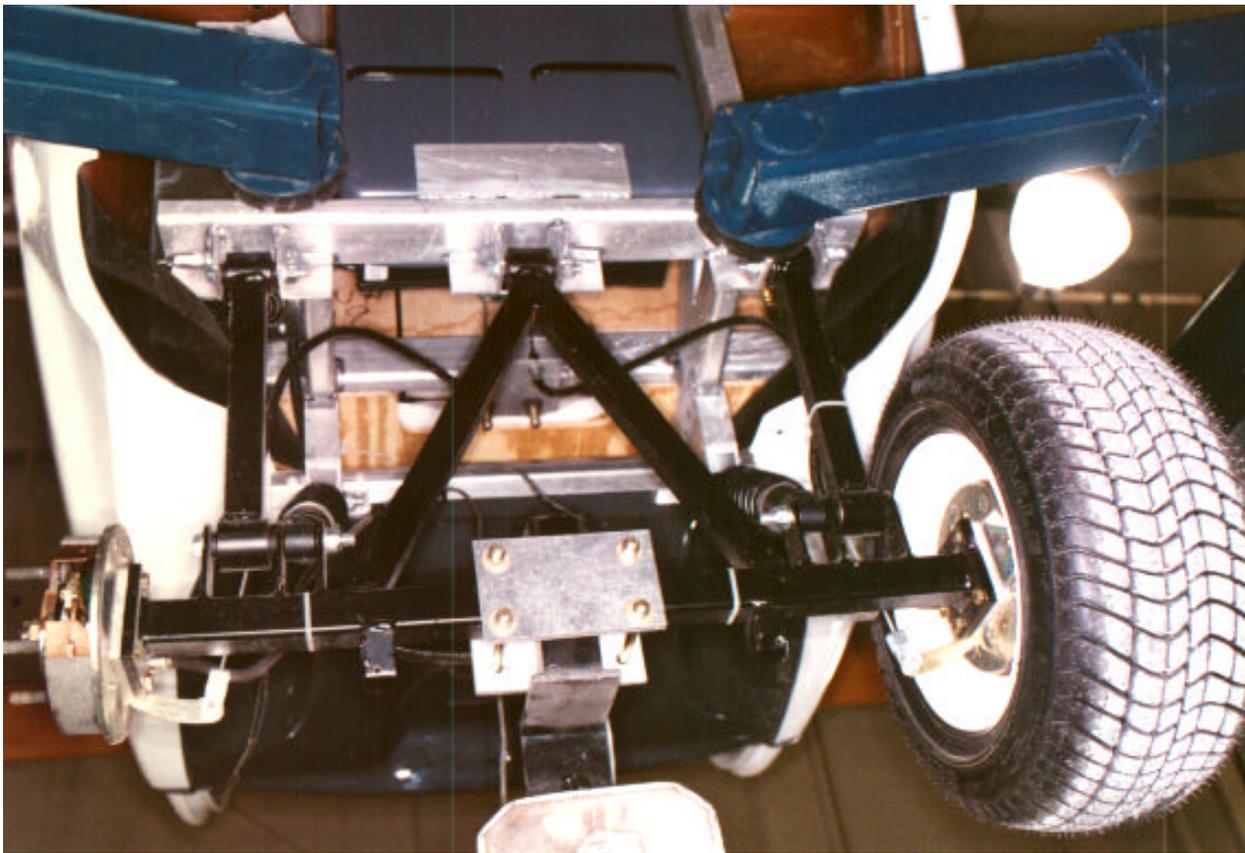
Figure 28 is a photograph of the rear suspension system taken from beneath the vehicle. The system used a solid rear axle that did not utilize a true independent suspension. It was mounted to the framework of the vehicle at three points. The shock system was anchored to the axle and to the framework at a fairly shallow angle. While the resulting system should be capable of normal motion in the vertical direction, there appeared to be relatively little torsional movement capabilities. This torsional “stiffness” would tend to couple the motion of the body of the vehicle to that of the rear axle. Thus, the vehicle would exhibit little or no body roll in a sharp (high g) turn. A possible consequence of this could be the lack of an “intuitive” feed back that a driver receives when cornering sharply, therefore increasing the possibility of rolling the vehicle in a high g turn.

Figure 28 - Rear Suspension System - As Seen From Beneath the Vehicle

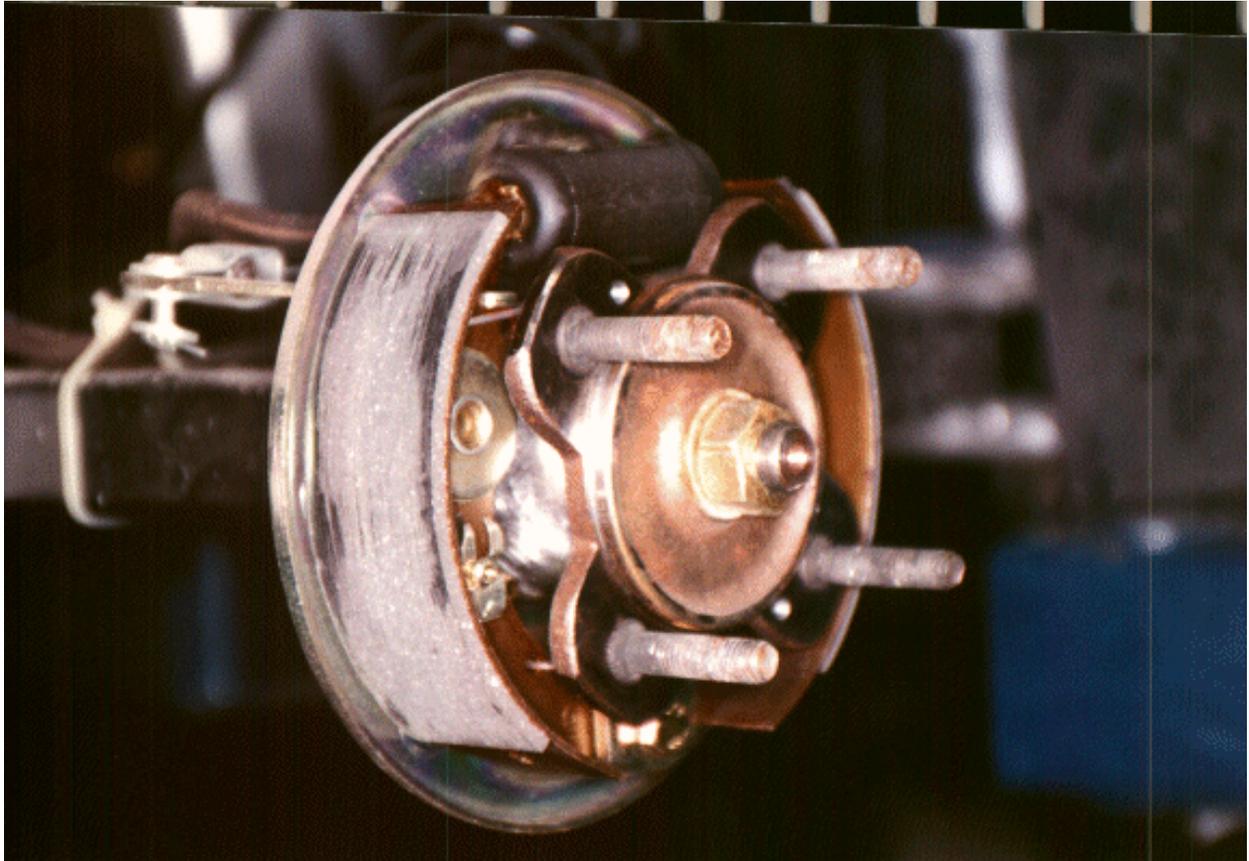
The GEM had hydraulic drum brakes for all four wheels. There was no power assistance for the system. The diameter of the drum was measured to be 6.34 inches. There was no apparent adjustment mechanism to take up slack in the brake system. Figure 29 is a photograph of the right rear wheel showing the wheel cylinder and pads for the system.

Figure 29 - Left Rear Brake Cylinder and Brake Pads

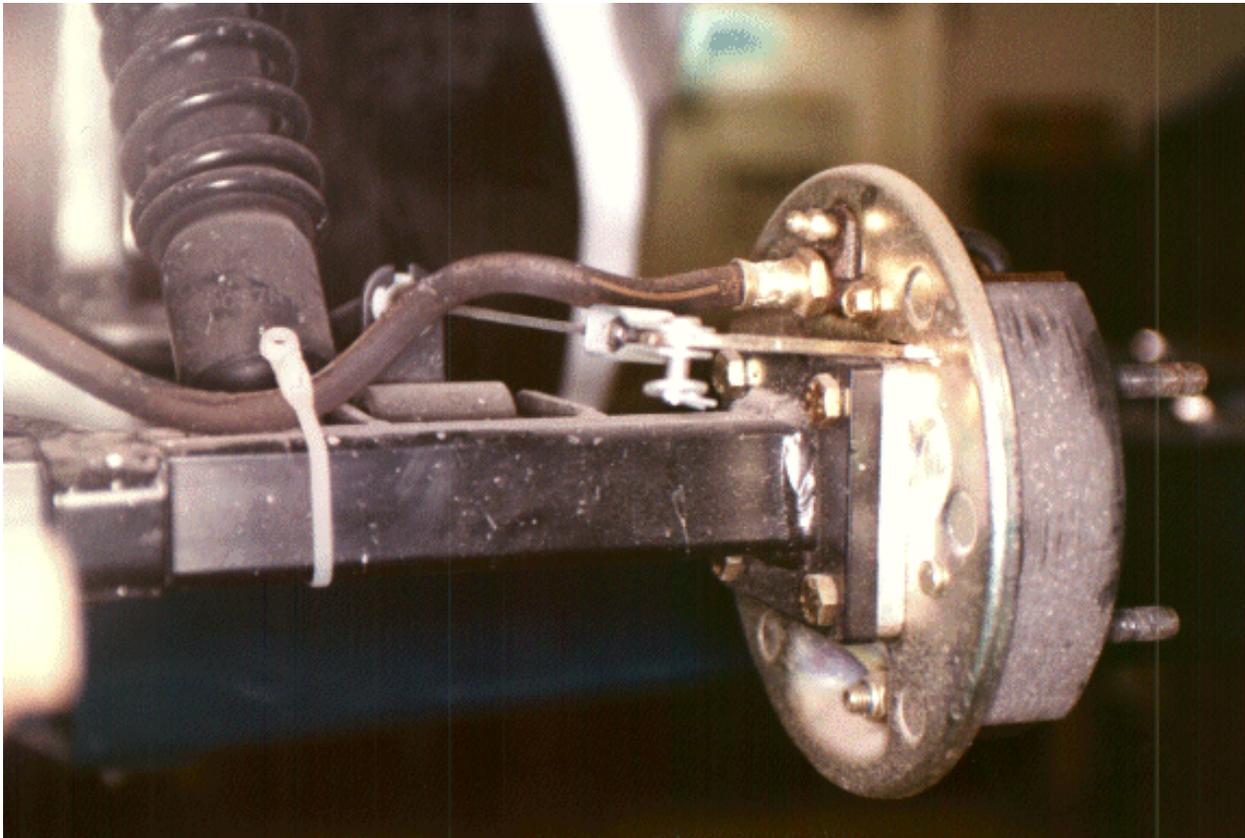
Figure 30 is a view of the left rear wheel showing the flexible brake line and the cable linkage of the parking brake. This photograph shows a potential hazard with this braking system. As shown in this photograph, the flexible line for the hydraulic brake system bridged over the cable for the parking brake system. In the photograph, the hose is not in contact with the cable, but as can be seen, the line is secured with tie wraps. Any inadvertent movement of the line could bring it into contact with the cable of the parking brake. If this occurs, the use of the parking brake will result in the cable sawing into the flexible cable, eventually causing a failure of the hydraulic system. Since the hydraulic system appeared to be a single unit, this would result in total failure of the hydraulic system

Figure 30 - Left Rear Axle - Hydraulic Brake Line and Parking Brake Cable

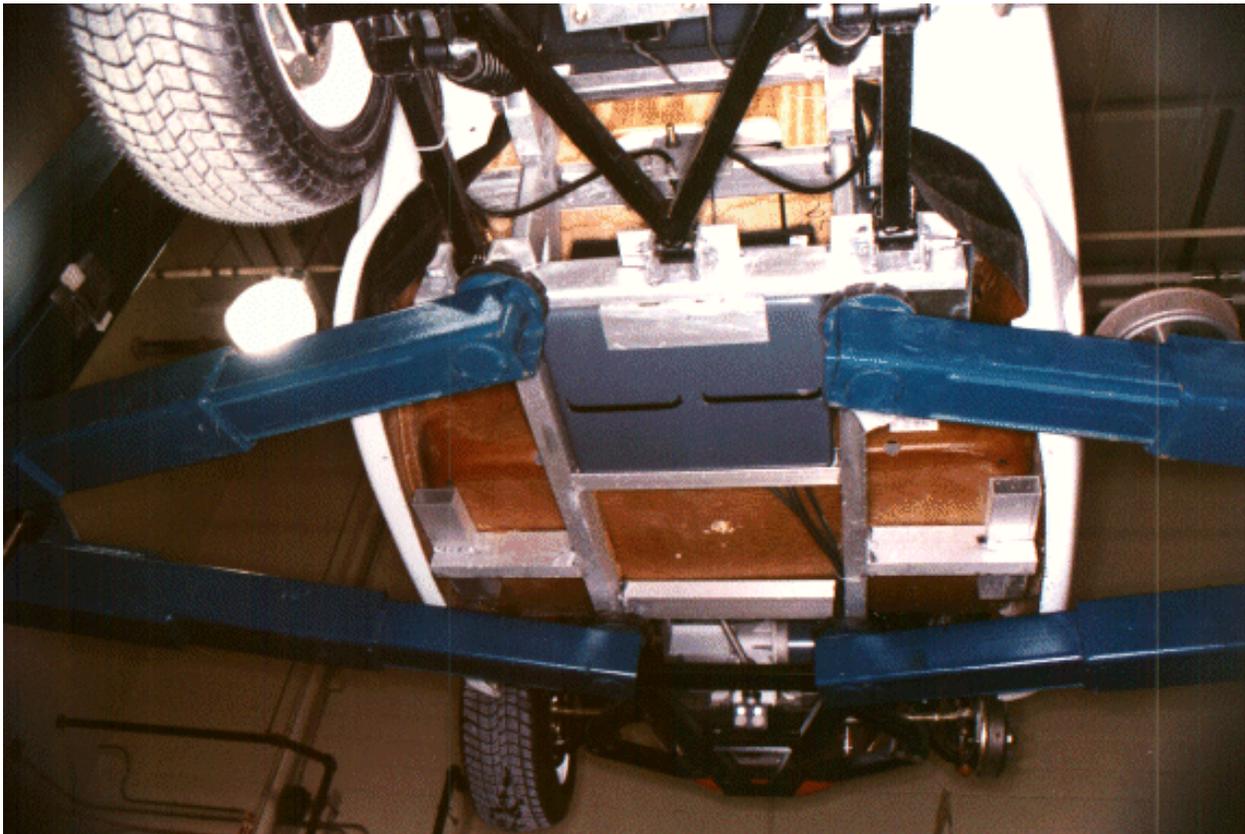
The GEM evaluated at the VRTC had a unique structure built around two ellipsoid aluminum hoops. These two hoops, which define the passenger compartment were crossed braced along the lower edges of the vehicle. Figure 32 is a photograph of the underside of the vehicle showing some of the cross struts along the bottom of the hoop structure. The upper edges of the hoops provided the attachment structure for the windshield and roof structure. The hoops also appeared to form a sort of roll cage for the vehicle. Since the hoops were not strongly crossed braced along the roof, their stability in the side loading that may occur in a rollover event (i.e., collapsing in a parallelogram mode) is not known.

Figure 32 - GEM - Framework Showing Aluminum Hoops and Cross Bracing

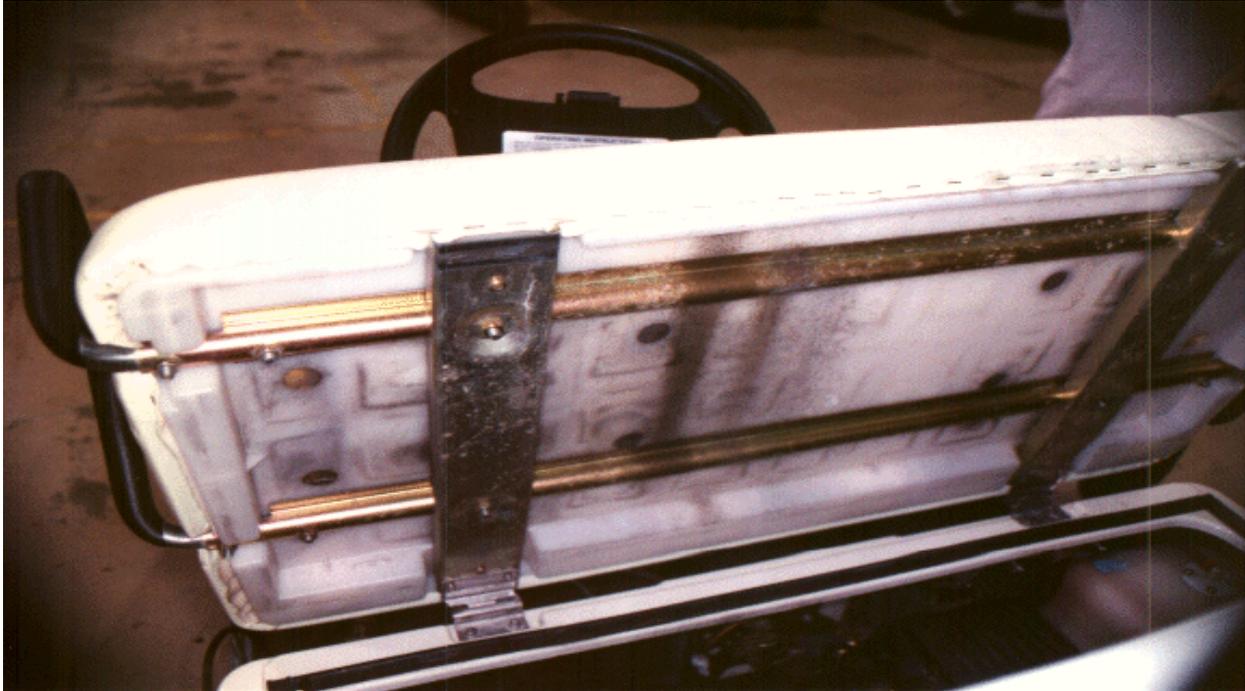
The addition of a belted safety restraint system to this vehicle should be possible, but would probably require some modification to the vehicle. The body of this vehicle was a thin composite/fiberglass shell. The major components of the vehicle (motor, fuel tank, drive train, etc.) were attached to a substantial tubular frame that formed the underside of the vehicle. The bench portion of the seat, seen in Figure 35, was flexible and lightly built with very little structural integrity.

Figure 35 - Details of Bench Seat

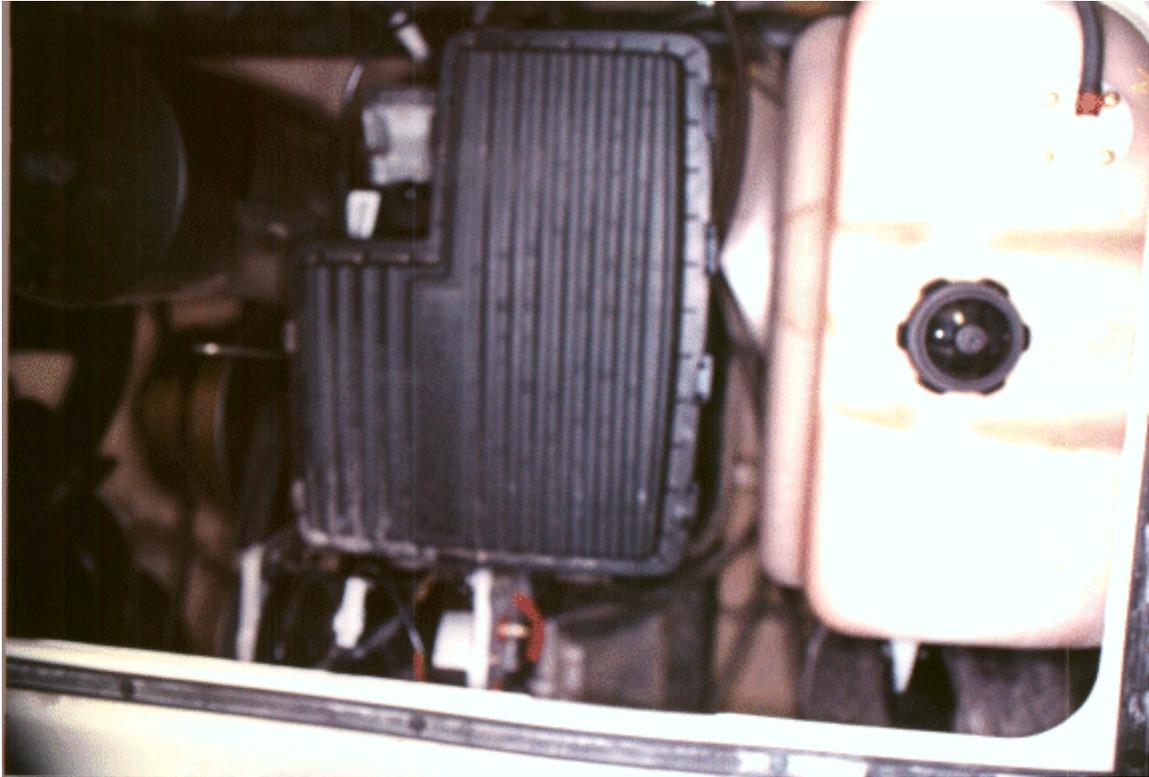
As can be seen in the photographs, there did not seem to be any seals or significant barriers to prevent fuel or caustic fluids from leaking from the engine compartment into the vehicle occupant area in the event of a rollover. This did not appear to present a significant problem in the vehicle's current configuration, but this may not be true if the maximum speed of the vehicle were increased and/or if the vehicle were fitted with a safety restraint system that retained/restrained occupants in a rollover.

Figure 37 - Right Side of Engine Compartment

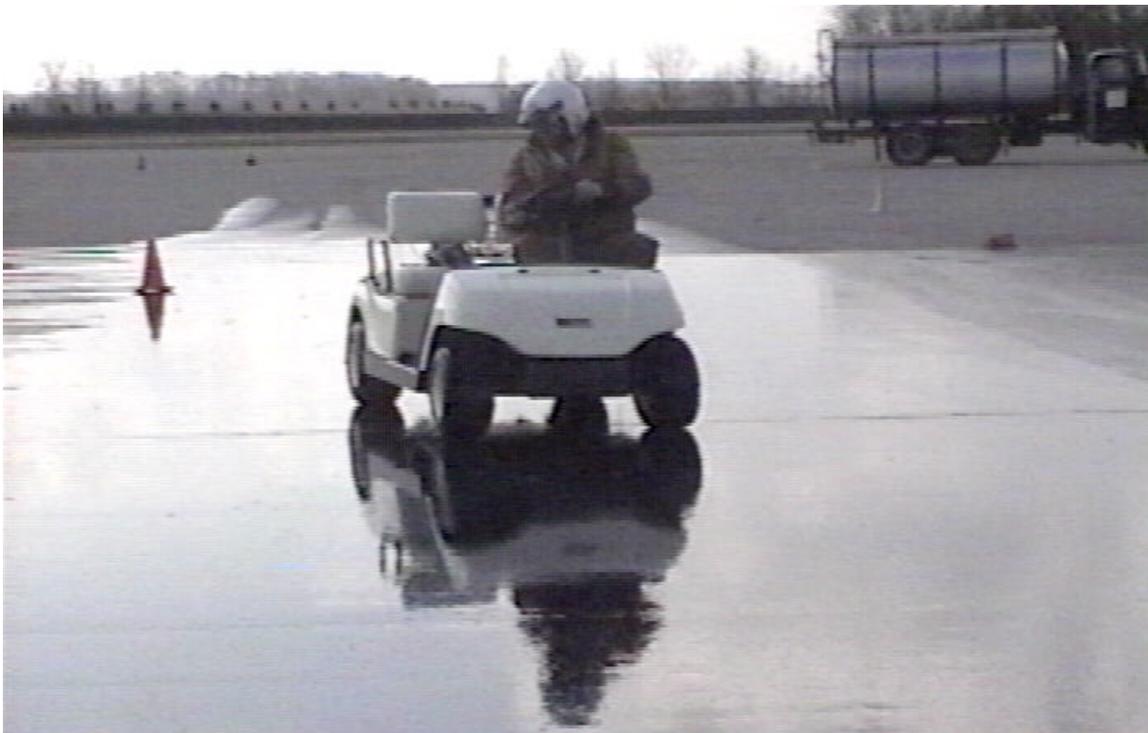
The brake lockup tests and best effort braking maneuvers on the Jennite surface resulted in some degree of spin in all of the tests conducted. This degree of instability was small and did not present any control problems for the driver at the speeds the vehicle was capable of obtaining. For these tests, lockup of the rear wheels was maintained while the driver used moderate steering efforts to maintain vehicle control (i.e., to steer out of the spin). Figures 51 and 52 are frames obtained from the video documentation of the Jennite surface brake tests. The first frame is at the beginning of the braking sequence while the second frame shows the vehicle at a stop at the end of the brake test. As can be seen in these images, the degree of spin was very small. Again, the comments of the driver for these tests indicated that while some out of line movement did occur, the vehicle always felt stable and controllable.

Figure 52 - Jennite Brake Test - Final Rest Position (Showing the Degree of "Spin")

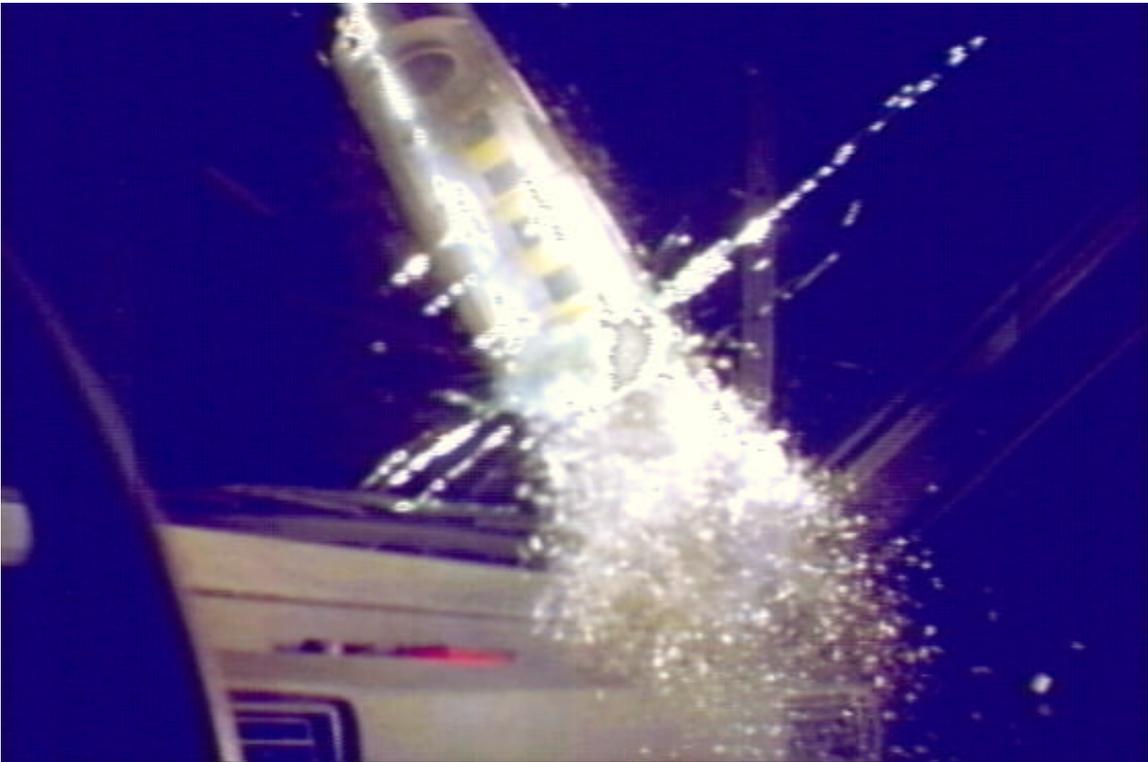
Figures 53, 54, and 55 are a series of images captured from the high speed digital camera recording of the 125 mph test. Figure 53 is an image of the golf ball in flight just before impact into the windshield of a 1985 Toyota Corolla. Figure 54 is 10 milliseconds later, showing the shower

Figure 54 - Golf Ball at Post Impact With Glass Spray (**Time = 10 ms**)

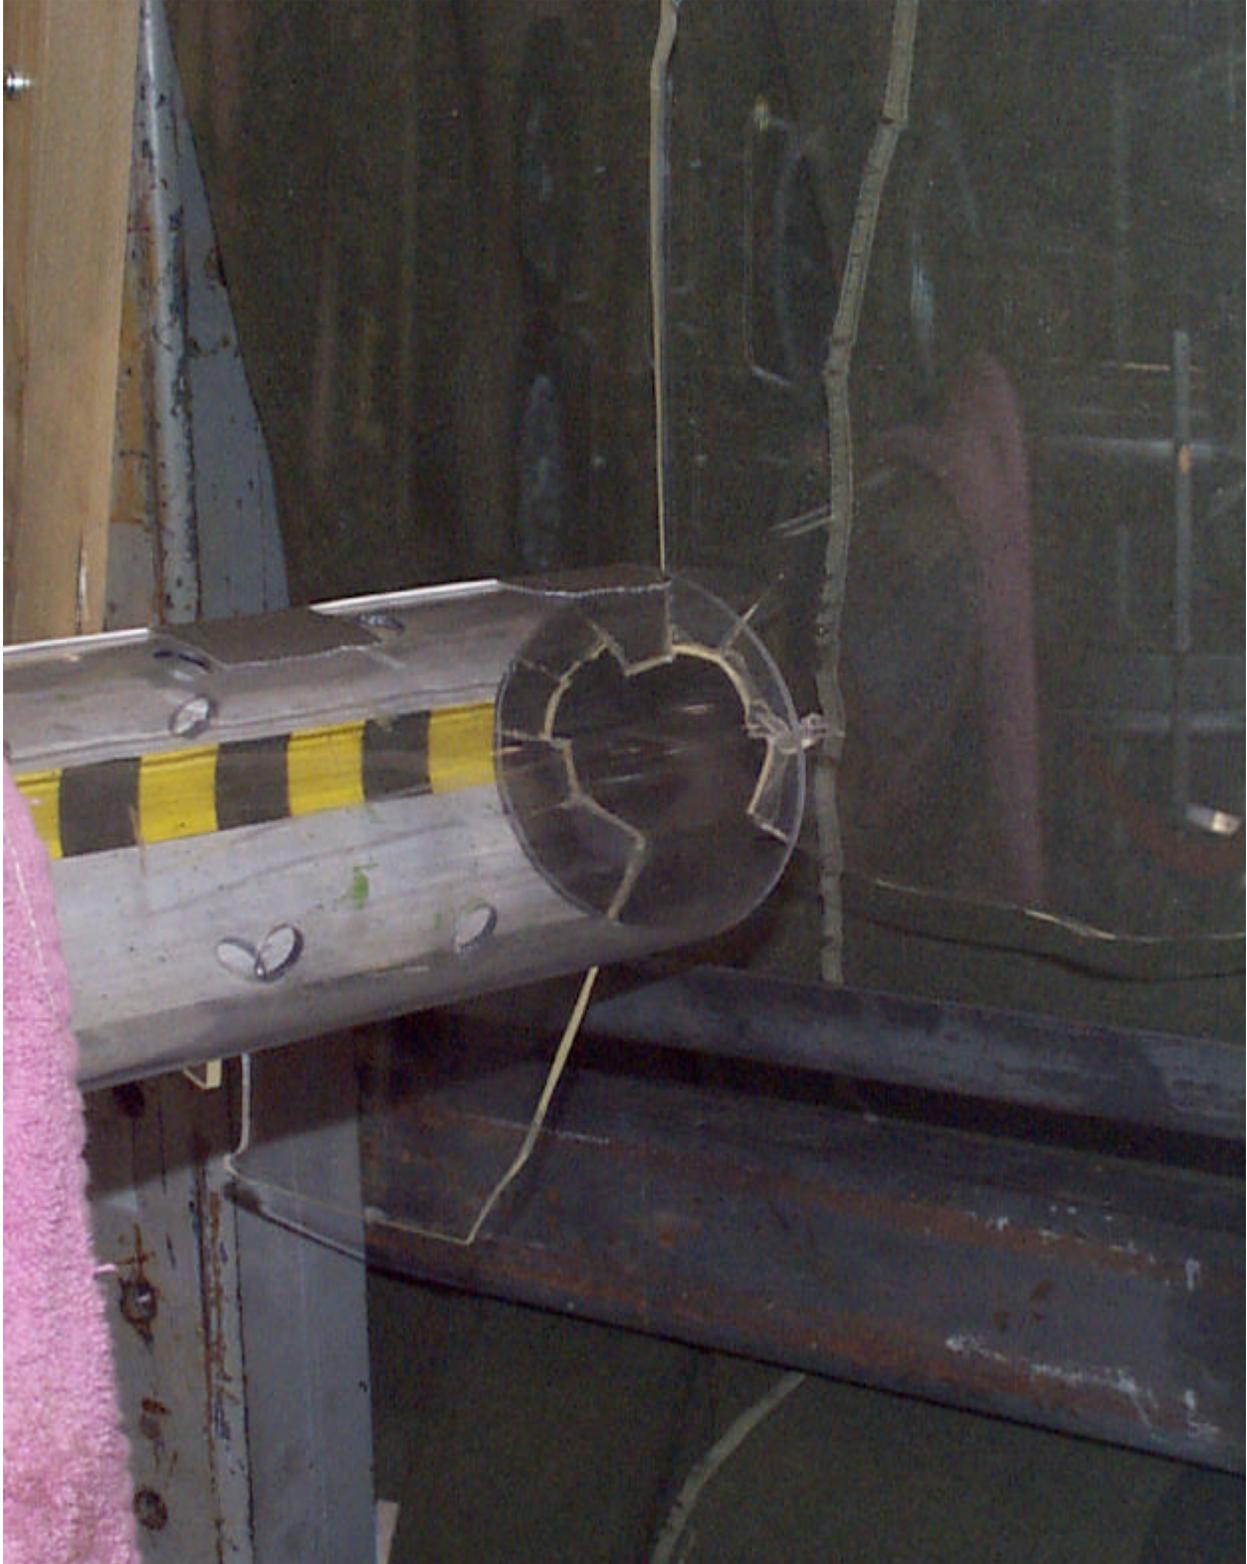
This windshield, which was an acrylic plastic, had a measured thickness of 0.1808 inches. The impact test was run at approximately 120-125 mph. The results of these tests are documented in Figures 56 and 57.

Figure 57 - Motorcycle Windshield Post-Test Showing Point of Impact and Fracture of Windshield.
